EFFECT OF TITANIUM, BORON AND MOLYBDENUM ON  
THE STRUCTURE OF AUSTENITIC 18/10 STEEL  
AFTER SOLUTION HEAT TREATMENT AND SENSITIZATION

Z. Bojarski, W. Czyrski,  
J. Eysymontt and H. Serwicki

Institute of Ferrous Metallurgy

Translation of "Wplyw tytanu, boru i molibdenu na strukture  
stali austenitycznych 18/10 w stanie przesyconym i  
po wyzarzaniu uczulajacym," Prace Instytutow Hut-  
niczych, vol. 23, no. 1, 1971, pp. 9-23.

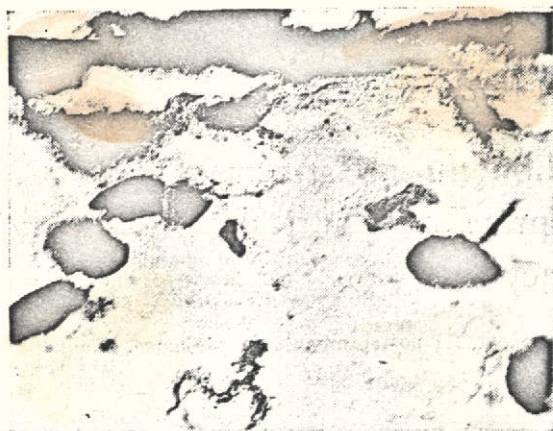
Fig. 1. OH18N9 steel. Structure after annealing for 3000 hours at 500°C. Minute  $M_{23}C_6$  carbides on the boundary between grains. Electron microscope. Carbide extraction replica. Magnified 100000 x.

Electron microscope studies of specimens annealed at 500°C for 10, 100 and 1000 hours did not reveal the precipitation process. The precipitation of very small carbides (Fig. 1) along the grain boundaries was only detected in an additional test specimen annealed for 3000 hours. Several groups of minute precipitates, not always bounded by grain boundaries were detected in a specimen annealed at 650°C for 10 hours. Only annealing for 100 hours at the same temperature caused clearly visible precipitation of carbides (Fig. 2) identified on the semiextraction replicas by selective electron diffraction as  $M_{23}C_6$  (Fig. 3). The use of extraction replicas made it possible to detect a very large number of carbides along the grain boundaries (Fig. 4). It was established that the preferred location for the precipitation of  $M_{23}C_6$  carbides are not only the grain boundaries, but also the zones around large inclusions or primary precipitates (Fig. 5).  $M_{23}C_6$  carbides were detected in a specimen annealed at 650°C for 1000 hours both on the grain boundaries and in the grains. Very large carbides occur along the grain boundaries. These probably originated as a result of the increase in many smaller carbides precipitated earlier, as well as minute carbides, which also occur in the grains (Fig. 6). A strip-like growth of carbides into the depth of one grain (Fig. 7) or two grains (Fig. 8) can be seen in some spots on the grain boundaries. This kind of carbide growth was observed also in the center of the grain and it begins on a large primary precipitate (Figs. 9, 10). The

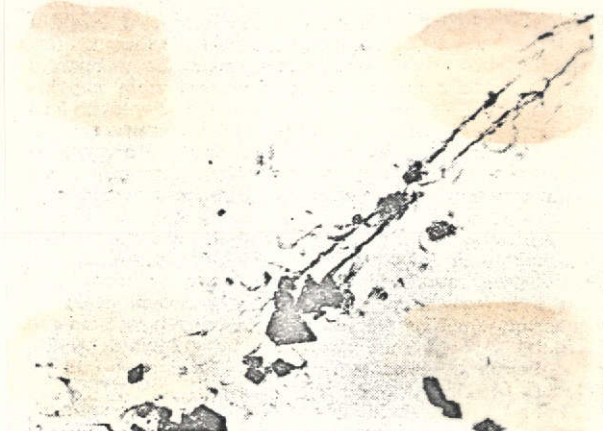
Fig. 2. OH18N9 steel. Structure after annealing: 650°C, 100 hours. Partially extracted  $M_{23}C_6$  carbides on boundary between grains. Electron microscope. Semiextraction replica. Magnified 25000 x.

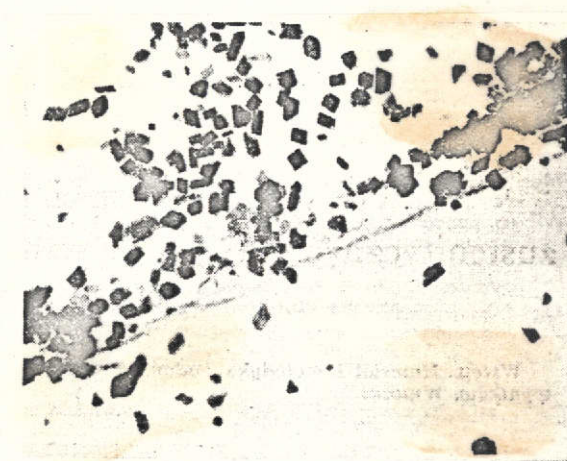
Fig. 4. OH18N9 steel. Structure after annealing: 650°C, 100 hours.  $M_{23}C_6$  carbides on boundary between grains. Electron microscope. Carbon extraction replica. Magnified 25000 x.

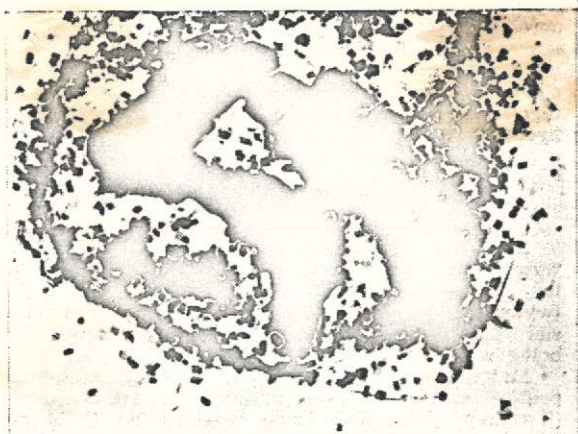
Fig. 5. OH18N9 steel. Structure after annealing: 650°C, 100 hours. Large inclusions or primary precipitates surrounded by minute precipitates are clearly visible. Electron microscope. Carbon extraction replica. Magnified 15500x.

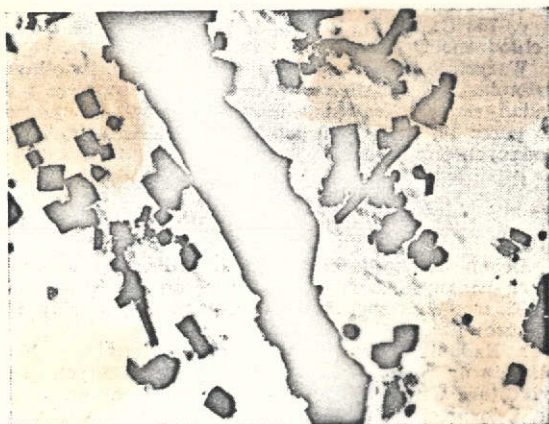
Fig. 6. OH18N9 steel. Structure after annealing: 650°C, 100 hours.  $M_{23}C_6$  carbons on boundary between grains and in grains. Carbon extraction replica. Magnified 25000 x.

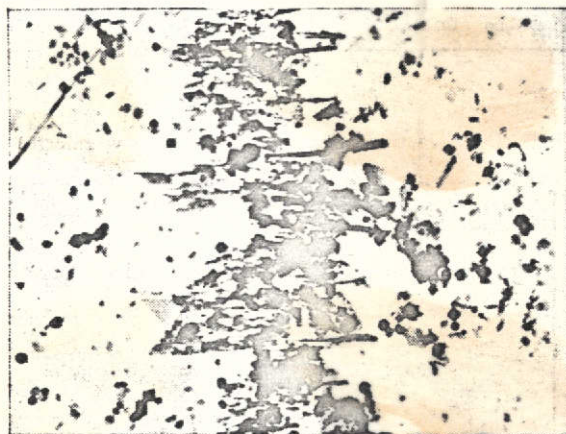
Fig. 8. OH18N9 steel. Structure after annealing: 650°C, 1000 hours.  $M_{23}C_6$  carbides on boundary between grains and in grains. Strip-like growth of carbides into both grains. Electron microscope. Carbide extraction replica. Magnified 15500 x.

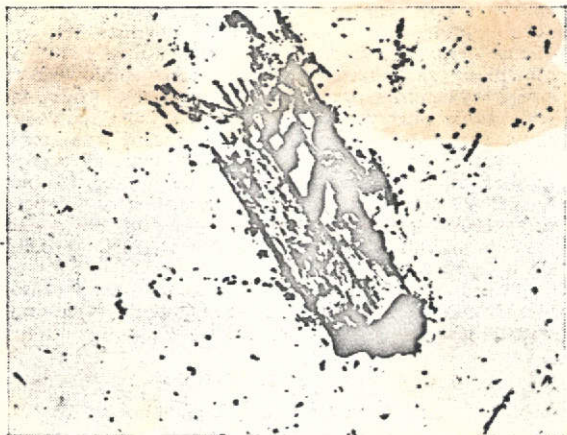
Fig. 9. OH18N9 steel. Structure after annealing: 650°C, 1000 hours.  $M_{23}C_6$  carbides growing out in strips from inclusion or primary precipitate in grain. Electron microscope. Carbide extraction replica. Magnified 4000 x.

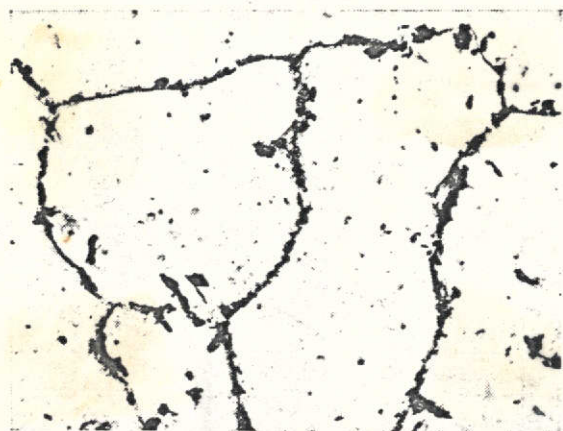
Fig. 19. IH18N10T steel. Structure after annealing: 650°C, 10 hours.  $M_{23}C_6$  carbide network on boundaries between grains. Electron microscope. Carbide extraction replica. Magnified 4000 x.

Annealing at 650°C causes the precipitation of large carbides throughout the entire annealing time, mainly along the grain boundaries. Fig. 19 shows the precipitations in a specimen annealed for 10 hours. The precipitates in specimens annealed for 100 and 1000 hours were identified as  $M_{23}C_6$ .

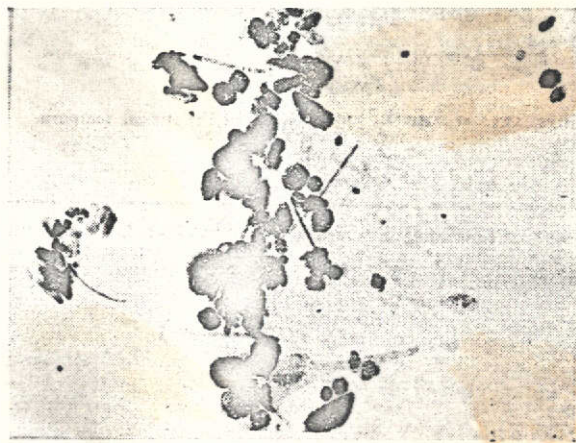
Fig. 20. IH18N10T steel. Structure after annealing: 700°C, 100 hours. Small carbides, partially with rounded shapes. Occasional small needles (according to W. Koch [7], the  $\sigma$ -phase). Carbide extraction replica. Magnified 25000 x.

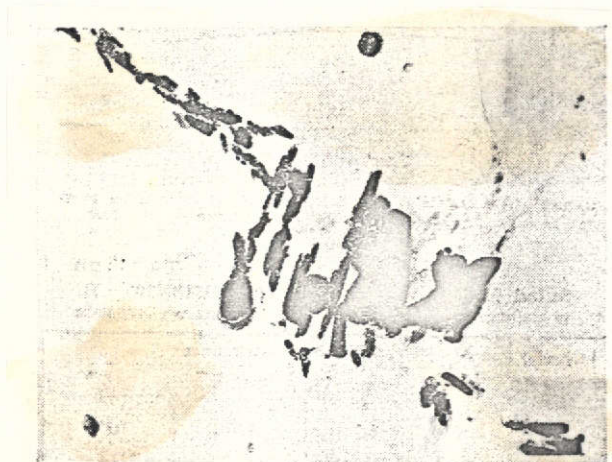
Fig. 22. IH18N10T+B steel. Structure after annealing: 650°C, 100 hours. Precipitation of carbides on boundary between two grains. Electron microscope. Carbide extraction replica. Magnified 25000 x.

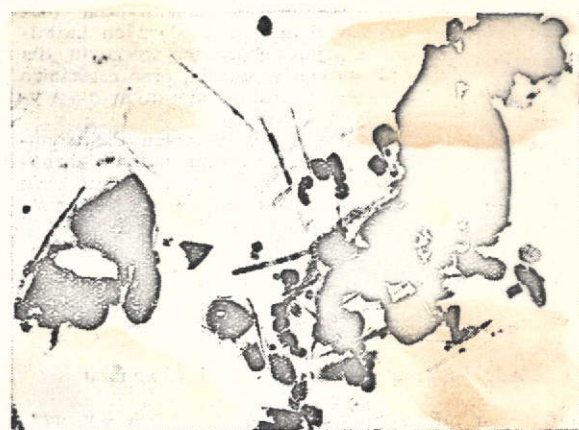
Fig. 23. IH18N10T+B steel. Structure after annealing: 750°C, 100 hours. Large carbide groups on boundary between two grains. Electron microscope. Carbide extraction replica. Magnified 25000 x.

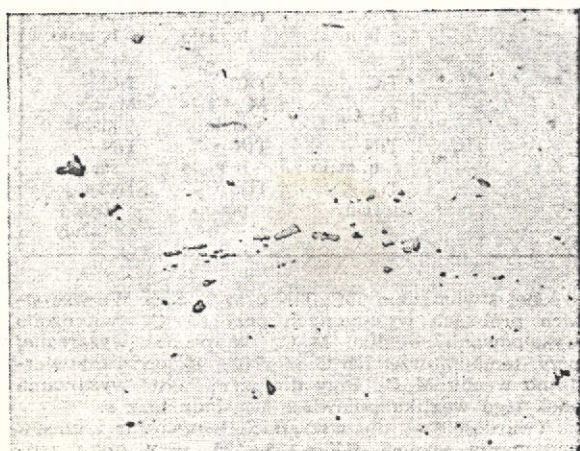
Fig. 25. IH18N10MT steel. Structure after solution heat treatment. Precipitates type B. Light microscope. Magnified 500 x.

Light microscope studies of unetched specimens showed the presence of oxides, sulfides and two types of precipitates designated as A and B (Fig. 25). The x-ray microanalyzer studies confirmed the presence of oxides. Precipitates type A were identified as  $\text{TiC}$  carbide (also containing iron) and precipitates type B as  $(\text{Ti,Fe}) (\text{S,C})$  (Fig. 26).

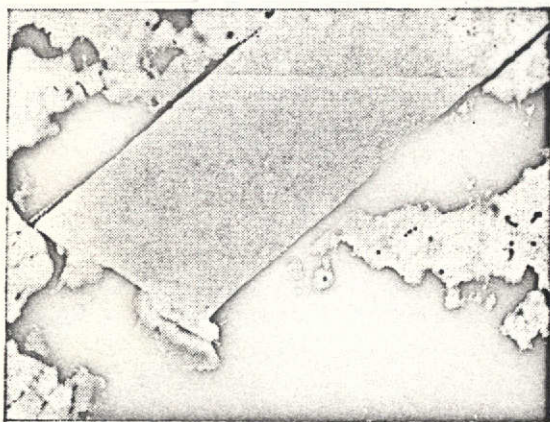
Fig. 29. IH18N10MT. Structure after solution heat treatment. Austenite with clearly visible twin crystal. Electron microscope. Thin foil. Magnified 25,000 x.

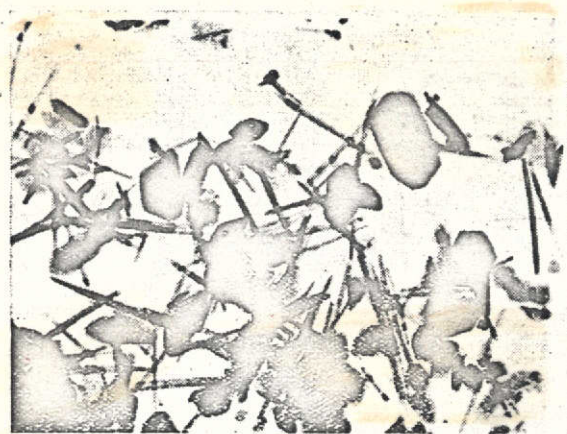
Fig. 33. IH18N10MT steel. Structure after annealing: 750°C, 1000 hours. Minute precipitates, partially with regular shapes and  $\sigma$ -phase needles. Electron microscope. Carbide extraction replica. Magnified 25000 x.

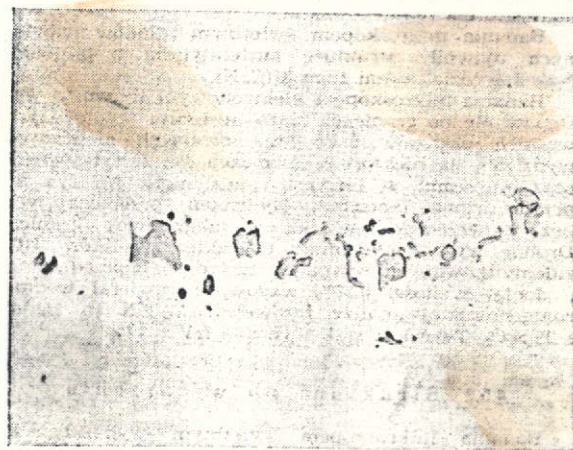
Fig. 39. IH18N10T's steel. Structure after solution heat treatment. Precipitates type B. Light microscope. Magnified 500 x.

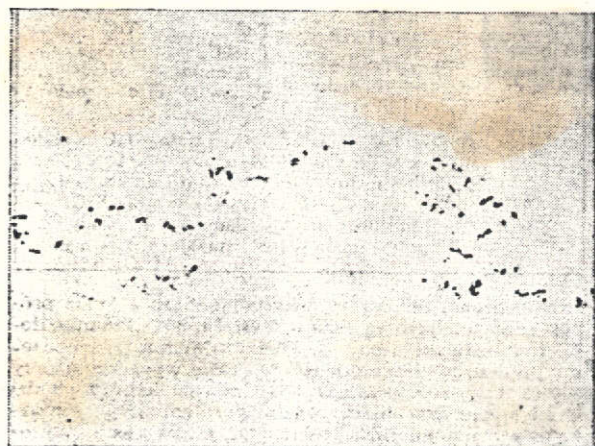
Fig. 41. IH18N10T "s" steel. Structure after solution heat treatment. Precipitates type C. Light microscope. Magnified 500 x.

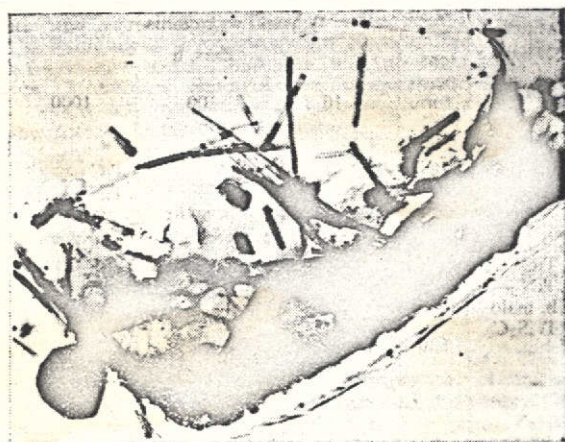
Fig. 44. IH18N10T"s" steel. Structure after annealing: 750°C, 1000 hours. Precipitates on boundary between austenite and ferrite.  $\delta$ -phase needles are clearly visible. Electron microscope. Carbide extraction replica. Magnified 25000 x.
